RELIGIOUS PROJECTS

New Construction / Restoration and Repairs

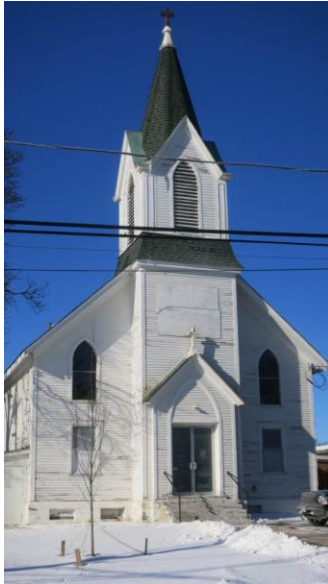
Left - Old St. Joseph Church – Round Lake, IL - Structural repairs and investigation of over 100 year old church. The investigation included repair recommendations on foundation system, framing and stability of steeple. Building has been decommissioned as a church and proposed as an alternate usage for a community center.

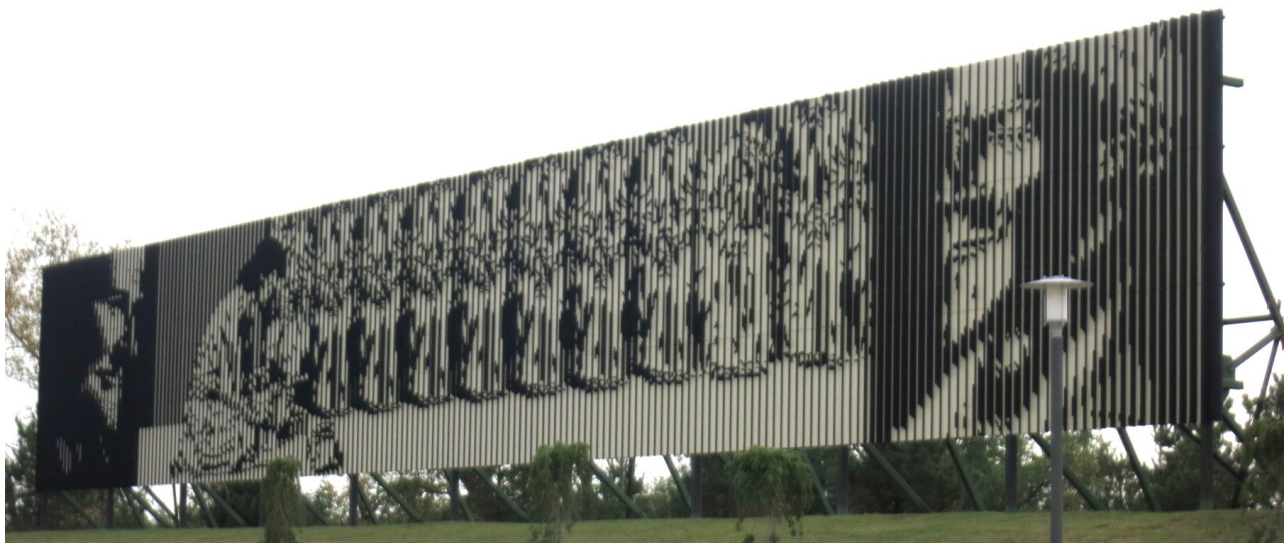
Below - Jesus washes the feet of his disciples. Made of over 2000 vertical stainless steel “sliding fins” cut by a laser “jig”, this mural as originally engineered for Catholic Charities in downtown Chicago on Randolph St. before being relocated to Holy Family Villa in Palos Park, a Catholic Charities Retirement Community. It is called a Shadow Mural as the sunlight on the mural “fins” creates different depictions of Jesus. The sister mural is in Paris, France.

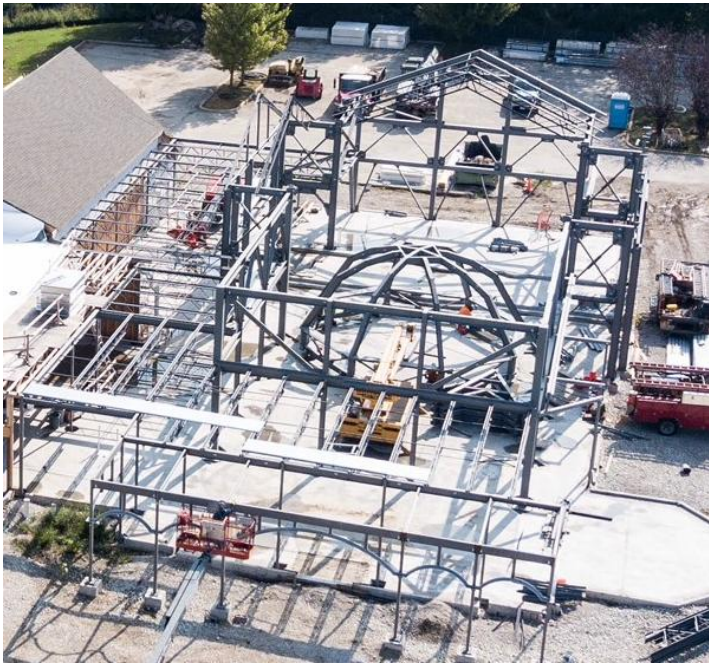
Above Left – Drone photo of a new Greek Orthodox Cathedral we designed shows framing with dome to be installed. Dome was lifted into place later with four tower cranes.

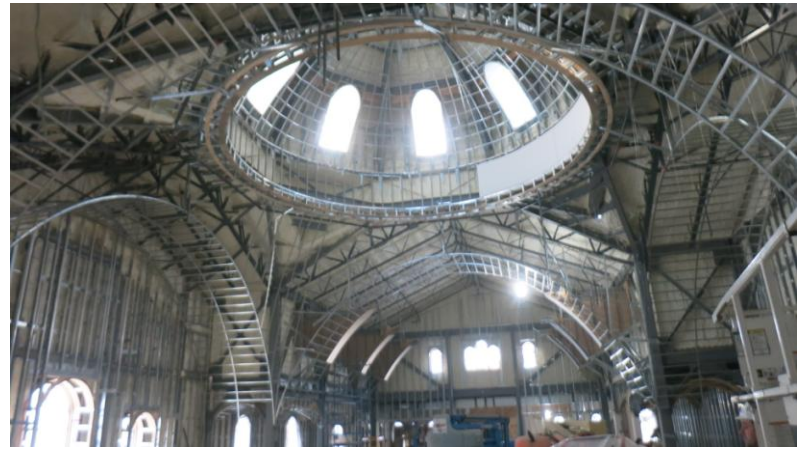
Above Right: Interior space mosaics and stained glass windows will encompass the entire inside space of the cathedral

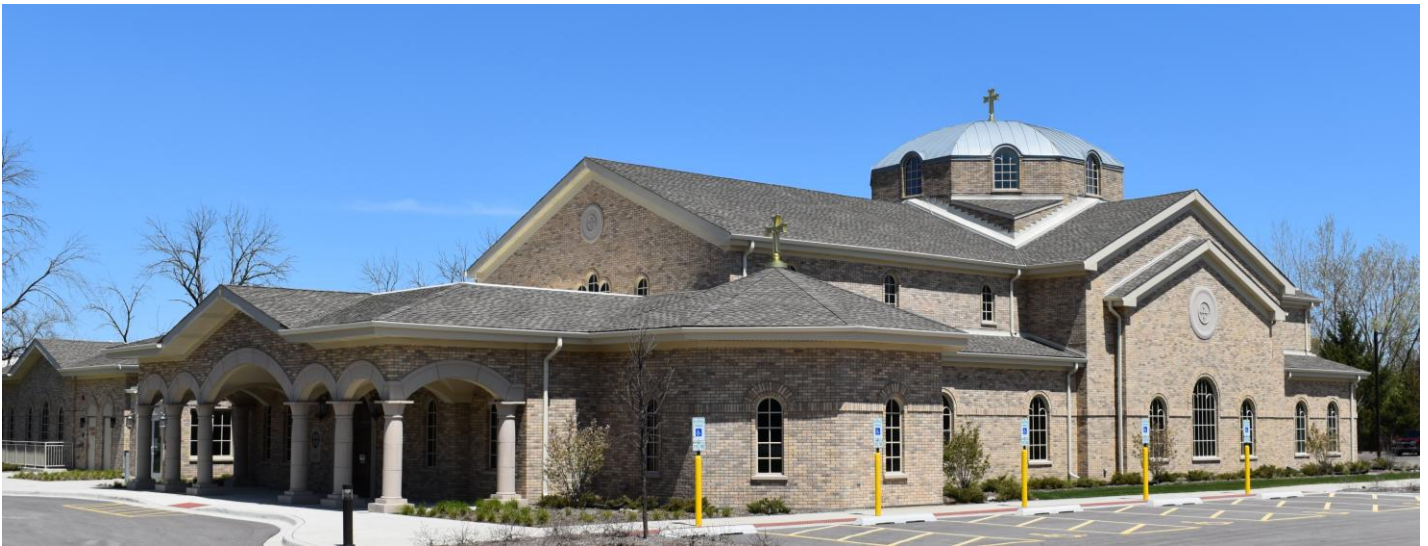
Below – Final completion of Greek Orthodox Cathedral.

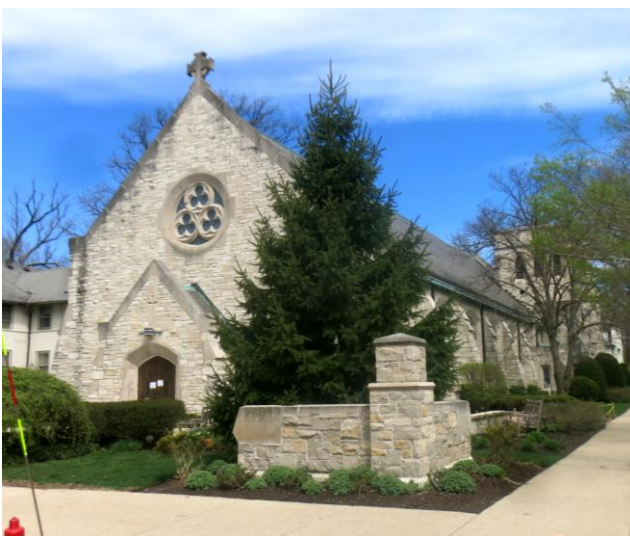
Far Left – St. Francis Xavier Catholic Church- Wilmette, IL. – Structural investigation of Gothic church constructed in 1939 to ascertain the cause of cracking of buttresses supporting the roof.

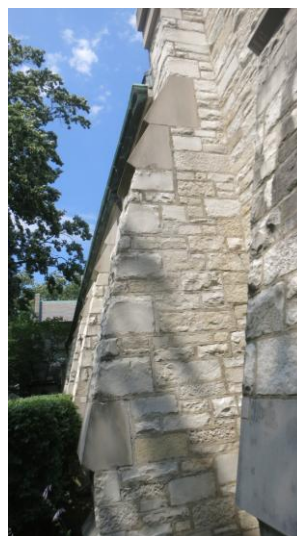
Left – Close-up of buttresses composed of limestone facing and brick interior with no reinforcement present. Tension forces present.

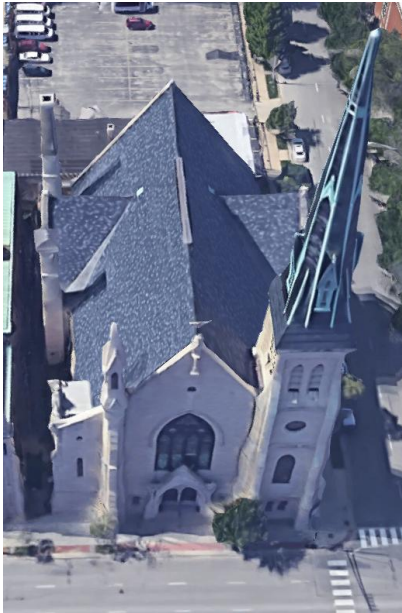
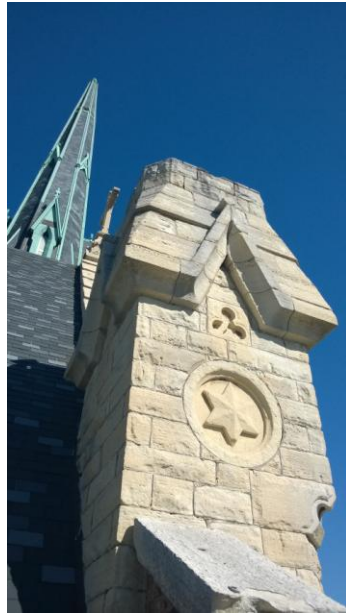
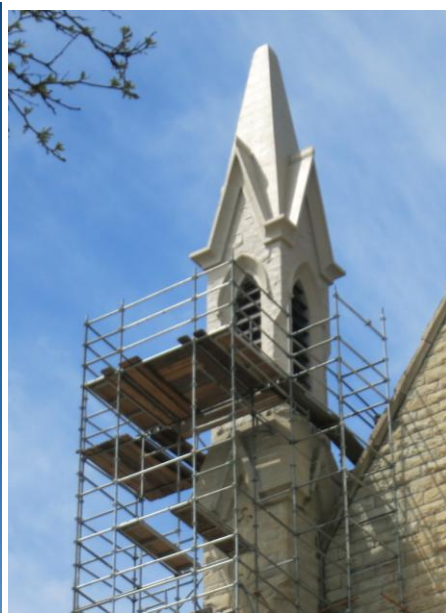
Above – First Baptist Congregation Church, Chicago, IL - Installation of new steeple as seen in photos above required a steel reinforced cage to be inserted in the church tower as masonry stresses did not allow direct attachment

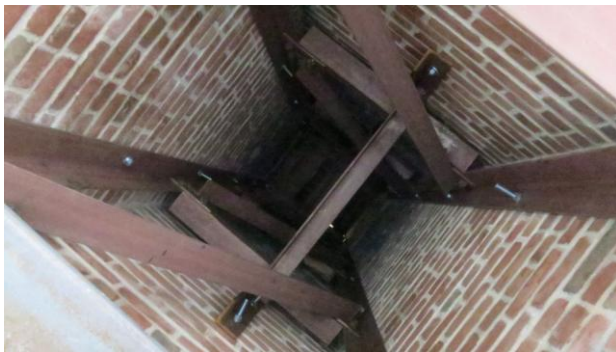
Left – Steel reinforced vertical truss installed into the vertical height of the masonry portion of the bell tower.

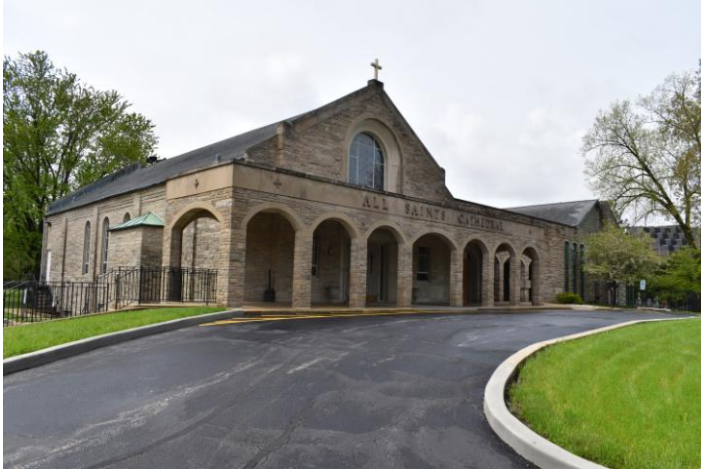
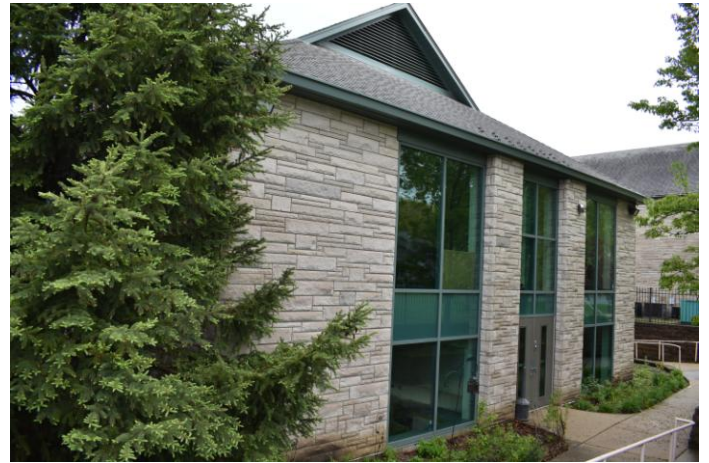
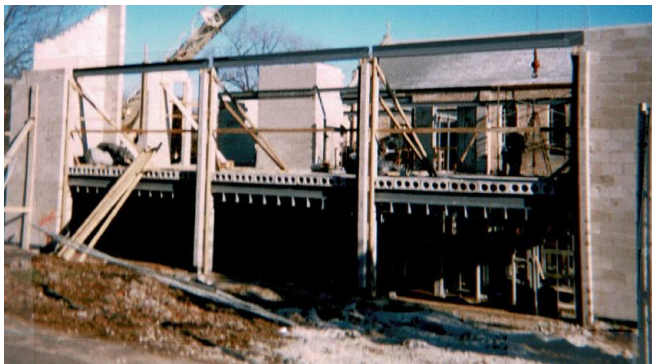
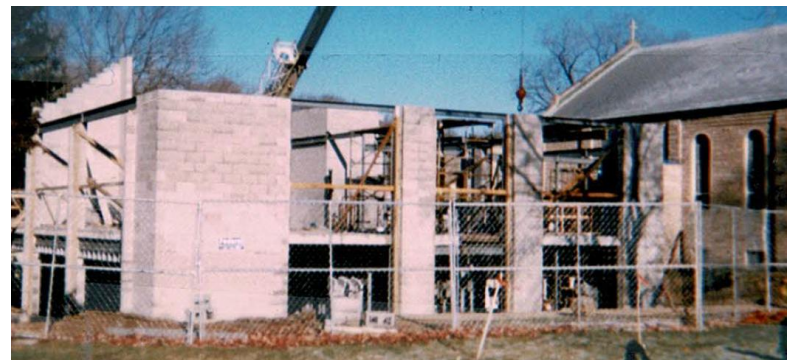
Above – All Saints Cathedral – Polish National Church – Chicago, IL. Photos above show completed church addition and work under construction. Structural design included steel framing, masonry bearing walls and precast concrete.

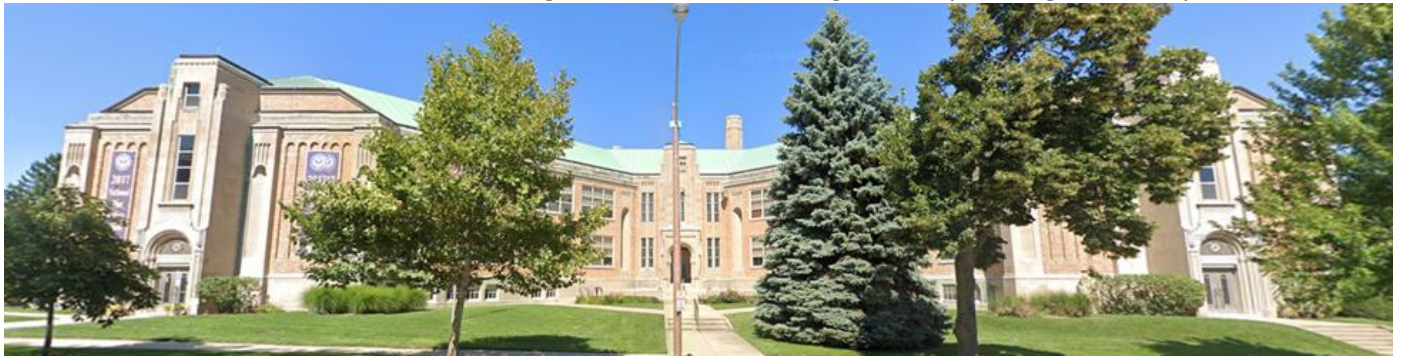
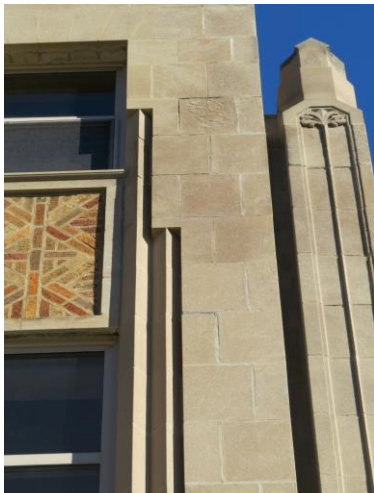
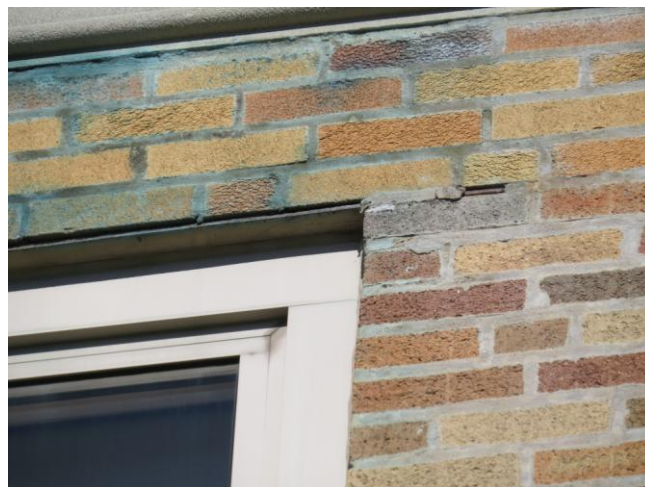
Above, Far Left and Left – St. Joseph Catholic Church School - Wilmette, IL – Structural investigation and repair program to the main school wood roof trusses as well as masonry repairs and lintel repairs to the limestone and face-brick.

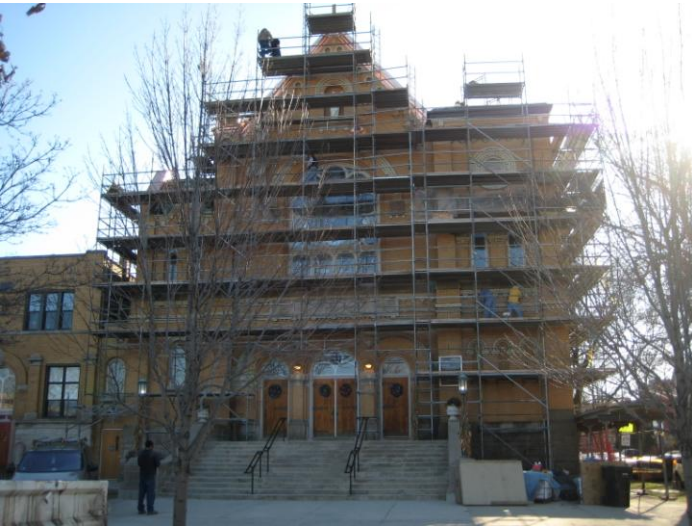
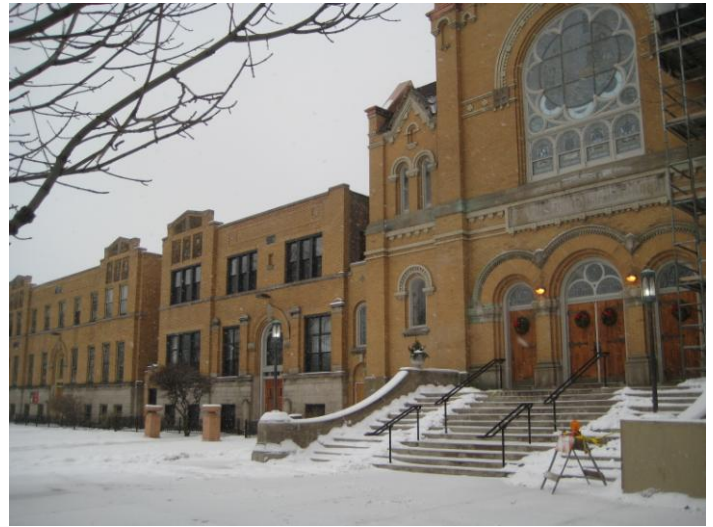
Above - St. John Berchmans Catholic Church – Chicago, IL – Five year structural repair program to the parish campus included restoration of church, administrative building and schools (5-building campus). Repairs included replacement of steel framing due to deterioration, bell tower framing repairs, roof truss system repairs and replacement with steel trusses in the main church and masonry repairs on all buildings.

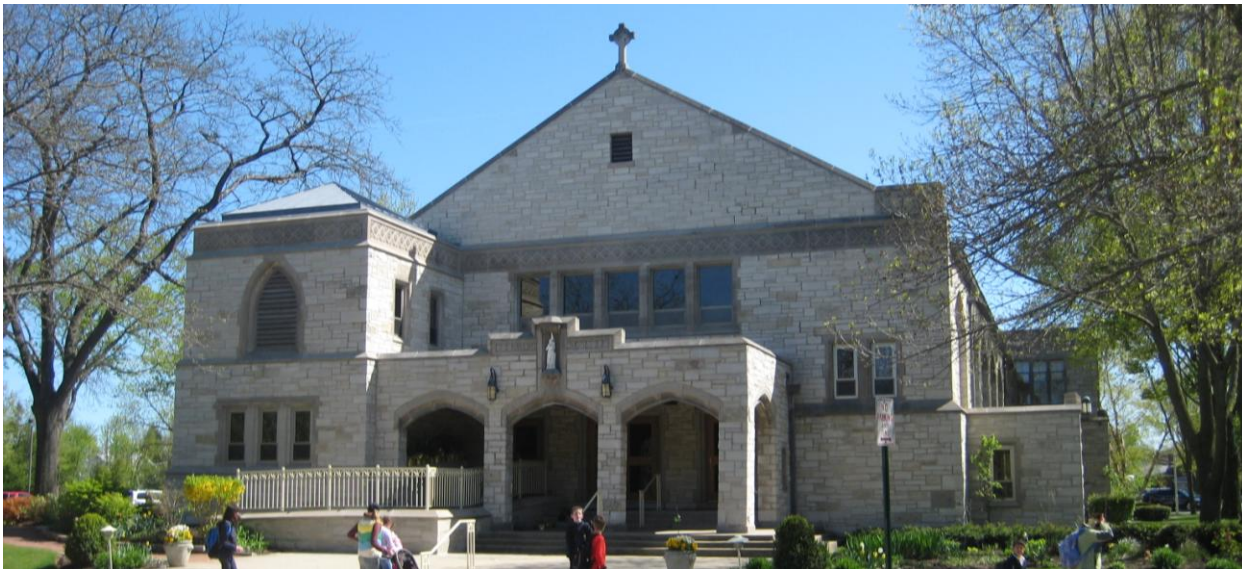
Above - St. Joan of Arc – Skokie, IL – Structural replacement of main church canopy entrance. New steel framing installed and existing limestone reinstalled. Damaged limestone matched and replaced with new limestone.

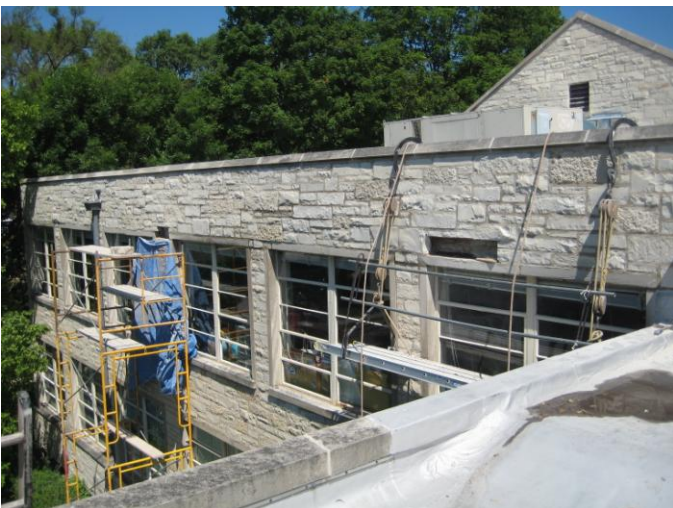
Left – St. Joan of Arc School – Skokie, IL – Bulging east wall in danger of collapse reinforced and strengthened without wall removal. Existing window deteriorated steel lintels and deteriorated limestone and mortar repaired or replaced at time of wall stabilization.

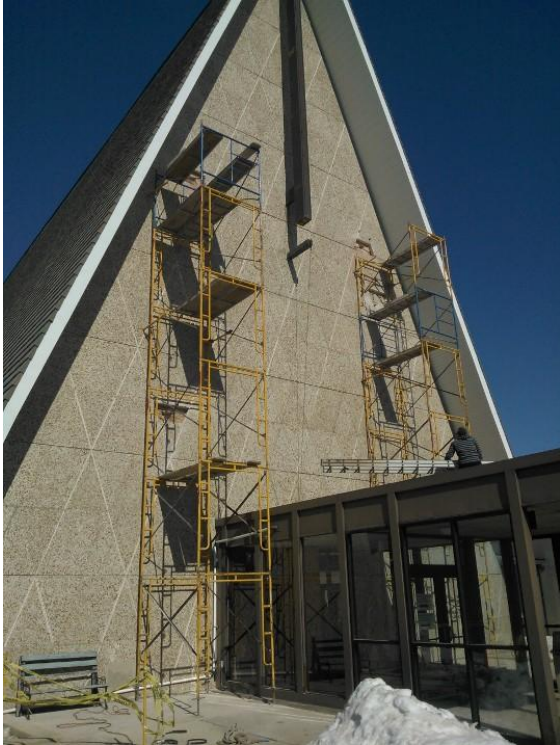
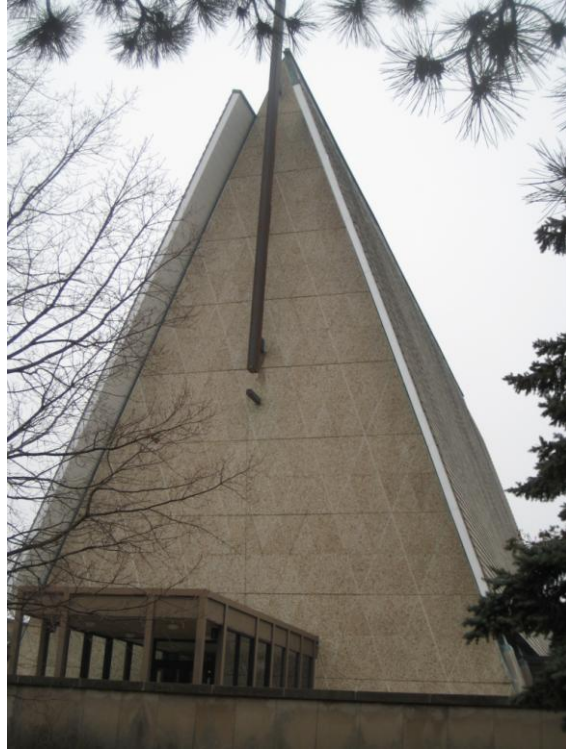
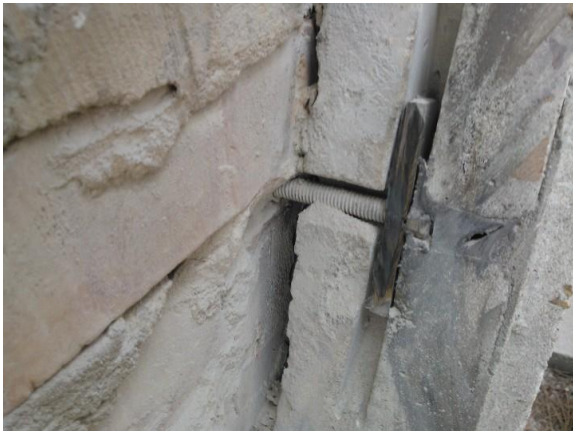
Above and Left – Lithuanian World Center – Lemont, IL
 “Loosely” patterned after the Air Force Academy Chapel in Colorado, a structural investigation was undertaken for repair of the precast concrete panels. Long term deterioration was causing the panels to dislodge with the potential of falling due to deterioration.

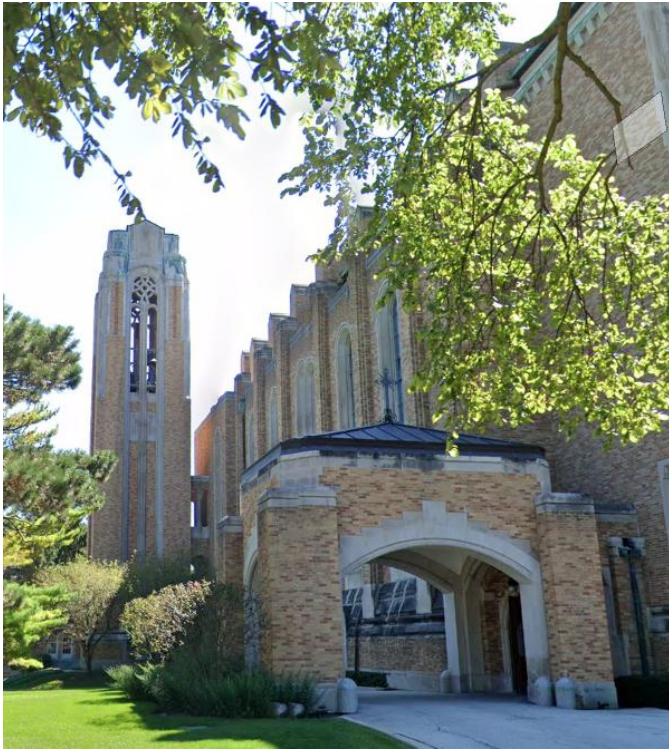
St. Joseph Catholic Church – Wilmette, IL. Built in 1939, our office was part of the team to develop repair solutions for the 100 foot bell tower of the church.

The tower is a full masonry structure designed to resist gravity and wind forces under the weight of the masonry only. No structural steel frame is present in the tower.
